**CONSOLIDATED SEWER MAINTENANCE DISTRICT
CONDITION ASSESSMENT PROGRAM REPORT
PROJECT NO. Y0TV0910C**

**CONDITION ASSESSMENT REPORT
COUNTY OF LOS ANGELES DEPARTMENT OF PUBLIC WORKS
CONSOLIDATED SEWER MAINTENANCE DISTRICT**

PROJECT NAME:	Y0TV0910C	PROJECT MGR:	Hanna Kebede
PROJECT DATE:	01/27/2011	CONTACT NO:	(626) 300-4686
SUP. DISTRICT(s):	5	MAP PAGE(S):	1851 & 1852
Report By:	Hanna Kebede	Report Date:	02/09/2013

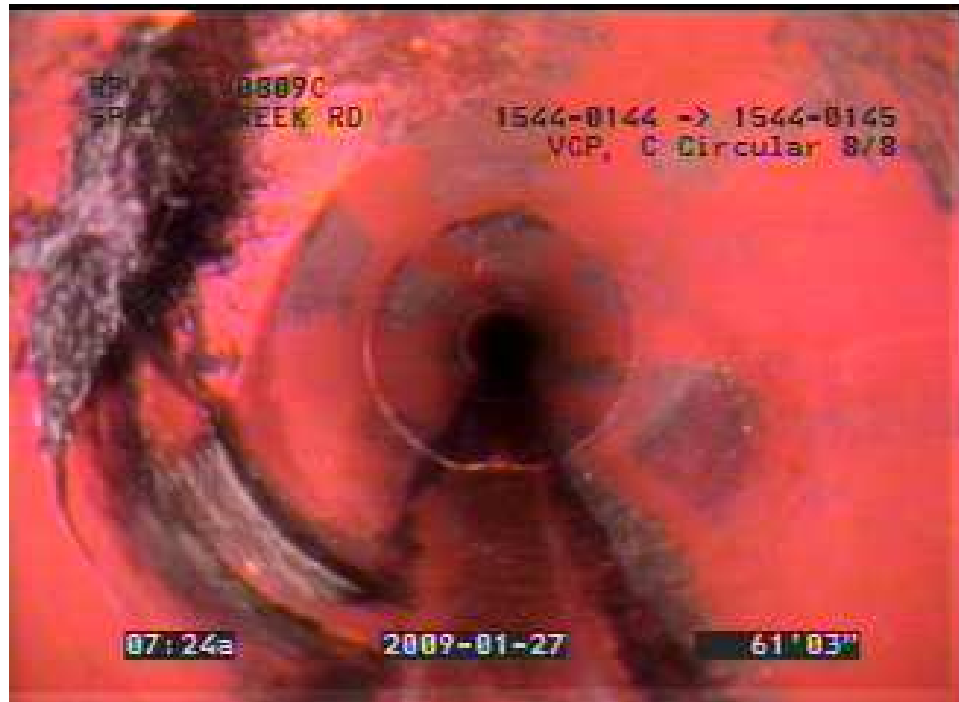
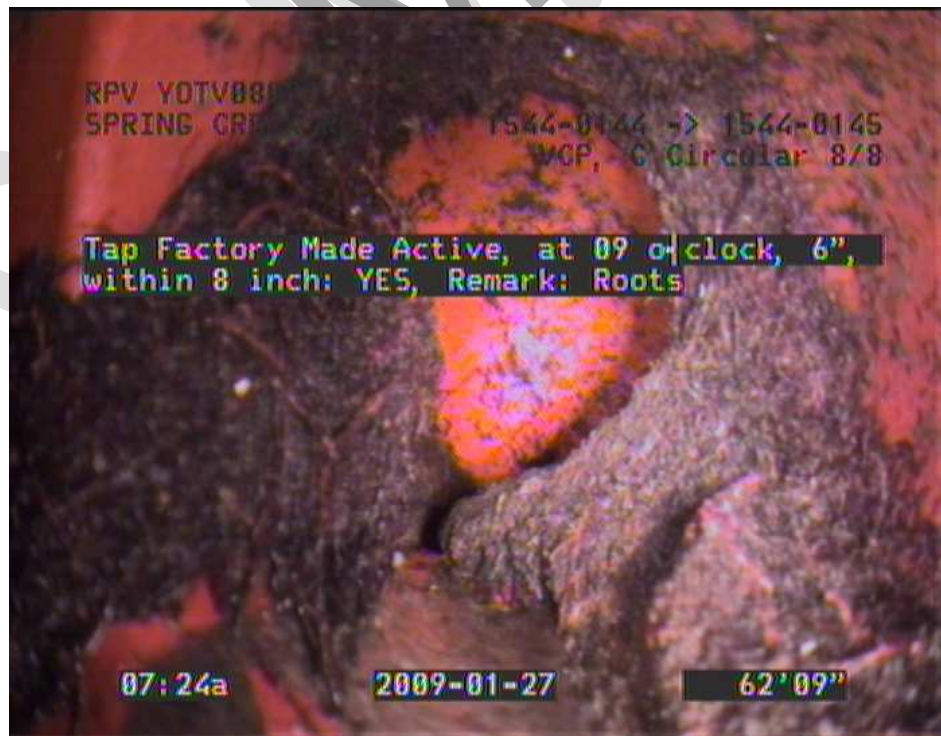
Since the CCTV inspection, the sewer mainline has been cleaned and blockages from root growth have been removed; however, the root blockage in your sewer lateral is still present. As the property owner, you are responsible for the entire length of the sewer lateral, which includes the portion that extends beyond the property line into the public right of way. We request that you contact a qualified plumbing contractor to service your sewer lateral within 90 days to remove roots and any other obstructions that may cause a sewage backup.

Roots at Lateral Connection

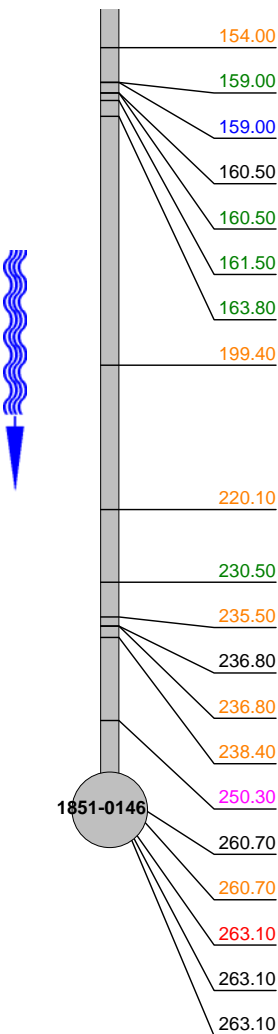
154.00	Crack Multiple, from 1 to 5 o'clock, within 8 inch: YES	S 3				
	159.00	Crack Circumferential, from 7 to 10 o'clock, within 8 inch: YES	S 1

159.00	Crack Longitudinal, at 10 o'clock, within 8 inch: YES	S 2				
	160.50	Tap Factory Active, at 9 o'clock, 6", within 8 inch: NO					
	160.50	Roots Fine Connection, from 7 to 9 o'clock, within 8 inch: NO	M 1

161.50	Crack Circumferential, from 2 to 5 o'clock, within 8 inch: YES	S 1				
	163.80	Crack Circumferential, from 1 to 4 o'clock, within 8 inch: YES	S 1

199.40	Crack Multiple, from 10 to 5 o'clock, within 8 inch: YES	S 3				
	220.10	Crack Multiple, from 2 to 5 o'clock, within 8 inch: YES	S 3				
	230.50	Crack Circumferential, from 2 to 5 o'clock, within 8 inch: YES	S 1

235.50	Crack Multiple, from 7 to 5 o'clock, within 8 inch: YES	S 3				
	236.80	Tap Factory Active, at 9 o'clock, 6", within 8 inch: NO					
	236.80	Roots Medium Lateral, at 9 o'clock, 30 %, within 8 inch: NO	M 3

238.40 S2	Crack Multiple, from 11 to 3 o'clock, within 8 inch: YES, Start	S 3				
	250.30	Fracture Multiple, from 7 to 5 o'clock, within 8 inch: YES	S 4

260.70 F1	Roots Fine Joint, from 7 to 5 o'clock, within 8 inch: YES, End					
	260.70 F2	Crack Multiple, from 11 to 3 o'clock, within 8 inch: YES, End	S 3

263.10	Broken, from 4 to 8 o'clock, within 8 inch: NO	S 5				
	263.10	Roots Fine Joint, from 3 to 9 o'clock, within 8 inch: YES					
	263.10	Manhole, within 8 inch: NO, Remarks: 1851-0146					
20							
QSR	QMR	SPR	MPR	OPR	SPRI	MPRI	OPRI
5141	3121	49	7	56	2.33	1.75	2.24

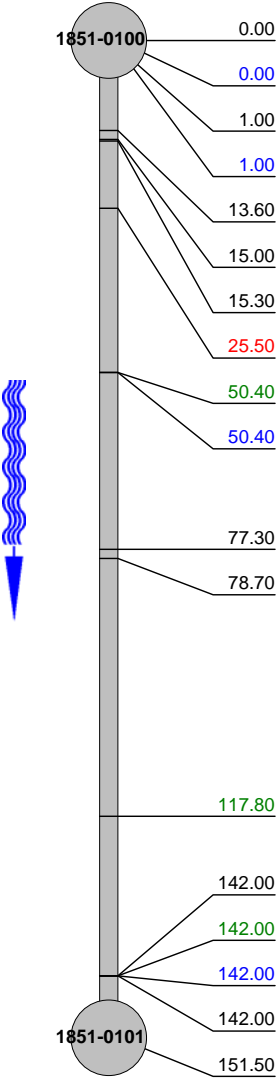
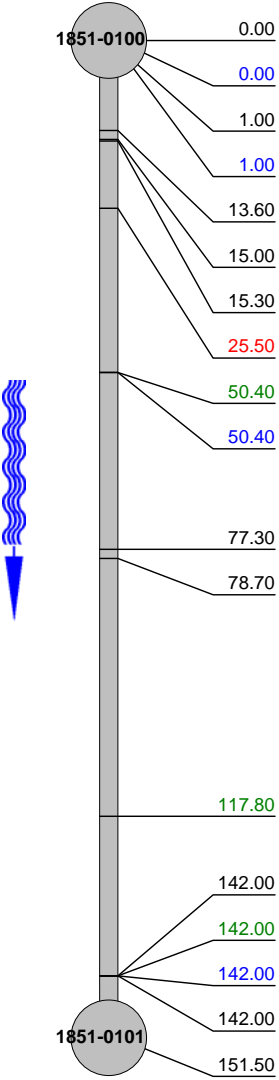
0.00	Manhole, within 8 inch: NO, Remarks: 1851-0100	0 FT // 00:00:36
	0.00	Water Level, 10 %, within 8 inch: NO	M 2

1.00	Roots Fine Joint, from 2 to 3 o'clock, within 8 inch: YES	
	1.00	Fracture Circumferential, from 7 to 6 o'clock, within 8 inch: NO	S 2
	13.60	Tap Factory Active, at 2 o'clock, 4", within 8 inch: NO

15.00	Tap Factory Active, at 2 o'clock, 4", within 8 inch: NO	
	15.30 S1	Roots Fine Joint, from 7 to 5 o'clock, within 8 inch: YES, Start	
	25.50	Broken Soil Visible, from 3 to 7 o'clock, within 8 inch: YES	S 5

78.70	Tap Factory Active, at 2 o'clock, 4", within 8 inch: NO	
	117.80	Crack Circumferential, from 3 to 6 o'clock, within 8 inch: YES	S 1
	142.00	Tap Factory Active, at 3 o'clock, 4", within 8 inch: NO

142.00	Joint Separated Medium, within 8 inch: YES	S 1

142.00 F2	Alignment Right, 15 %, within 8 inch: NO, End	M 2
	142.00 F1	Roots Fine Joint, from 7 to 5 o'clock, within 8 inch: YES, End

151.50	Manhole, within 8 inch: NO, Remarks: 1851-0101	
2

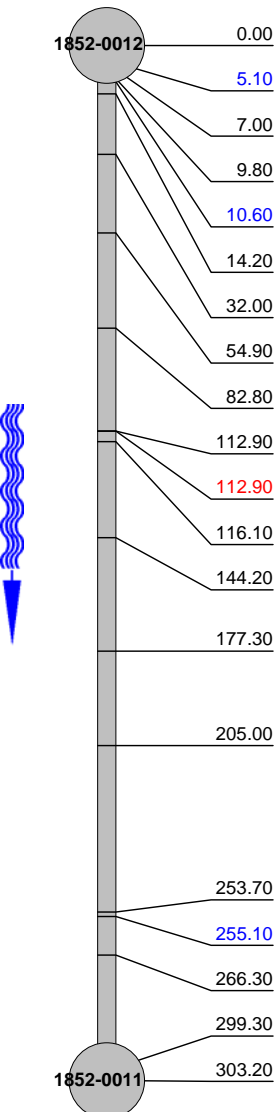
1852-0012	Manhole, within 8 inch: NO, Remarks: 1852-0012

5.10	Water Level, 5 %, within 8 inch: NO	M 2				
	7.00	Tap Factory Active, at 9 o'clock, 6", within 8 inch: NO					
	9.80	Tap Factory Active, at 3 o'clock, 6", within 8 inch: NO

255.10	Fracture Circumferential, from 8 to 11 o'clock, within 8 inch: YES	S 2				
	266.30	Tap Factory Active, at 3 o'clock, 6", within 8 inch: NO					
	299.30	Tap Factory Active, at 9 o'clock, 6", within 8 inch: NO					
	1852-0011	Manhole, within 8 inch: NO, Remarks: 1852-0011					
QSR	QMR	SPR	MPR	OPR	SPRI	MPRI	OPRI
5121	2200	7	4	11	3.5	2	2.75

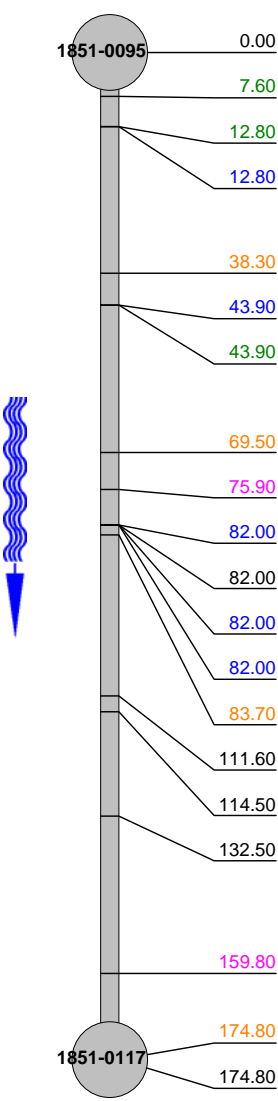
1851-0095 0.00	Manhole, within 8 inch: NO, Remarks: 1851-0095

7.60	Crack Circumferential, from 9 to 4 o'clock, within 8 inch: YES	S 1				
	12.80	Crack Circumferential, from 3 to 9 o'clock, within 8 inch: YES	S 1

12.80	Water Level, 25 %, within 8 inch: NO	M 2				
	38.30	Crack Multiple, from 7 to 4 o'clock, within 8 inch: YES	S 3				
	43.90	Water Level, 15 %, within 8 inch: NO	M 2

43.90	Crack Circumferential, from 8 to 3 o'clock, within 8 inch: YES	S 1				
	69.50	Crack Multiple, from 7 to 5 o'clock, within 8 inch: YES	S 3				
	75.90	Fracture Multiple, from 12 to 9 o'clock, within 8 inch: YES	S 4

82.00	Fracture Circumferential, from 2 to 4 o'clock, within 8 inch: YES	S 2				
	82.00	Tap Factory Active, at 12 o'clock, 6", within 8 inch: NO					
	82.00	Crack Longitudinal, at 12 o'clock, within 8 inch: NO	S 2

82.00	Infil Weeper, at 12 o'clock, within 8 inch: NO	M 2				
	83.70 S1	Crack Multiple, from 7 to 5 o'clock, within 8 inch: YES, Start	S 3				
	111.60	Tap Factory Active, at 12 o'clock, 6", within 8 inch: NO

114.50	Tap Factory Capped, at 9 o'clock, 6", within 8 inch: NO					
	132.50	Tap Factory Active, at 12 o'clock, 6", within 8 inch: NO					
	159.80	Fracture Multiple, from 7 to 5 o'clock, within 8 inch: YES	S 4

174.80 F1	Crack Multiple, from 7 to 5 o'clock, within 8 inch: YES, End	S 3				
	174.80	Manhole, within 8 inch: NO, Remarks: 1851-0117					
QSR	QMR	SPR	MPR	OPR	SPRI	MPRI	OPRI
4234	2300	27	6	33	2.45	2	2.36

9	423D	1851-0095	1851-0117	BURNING TREE DR	Fractures: 75', 159'; infiltration: 82'; cracks	Lining: MH to MH	175
10	4122	1851-0150	1851-0149	MEADOWVIEW DR	Broken at base of MH 149	CSMD will repair base of MH 149.
